## Diagnosis and Rehabilitation of Loreto's Church Roof

**Abstract** Located in the heart of Chiado, Lisboa, Nossa Senhora do Loreto Church may be found between Largo das Duas Igrejas and Largo de Camões. This case study is focused on the problems observed inside the church as an effect of structural and construction systems of the gabled roof of the central nave. The main problems observed are due to the presence of water that affects the interior coatings, inciting their deterioration, the spread of humidity and also consequence of the degradation of the timber elements that compose the roof and floor system.

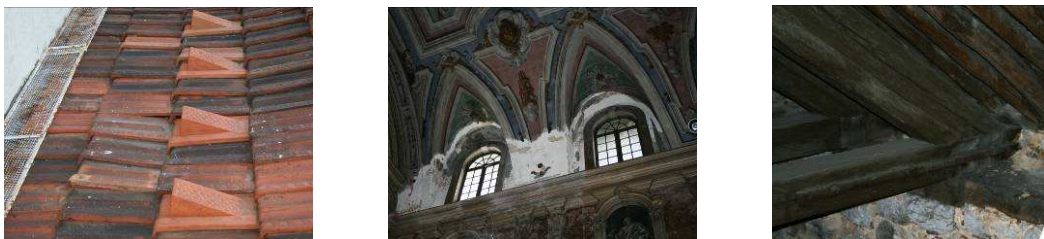
The main problems observed are due to the presence of water that affects the interior coatings, inciting their deterioration, the spread of humidity and also the degradation of the timber elements that compose the roof and floor system.

During the course of this study several problems were identified, and a rehabilitation plan for the Church building was made. The most significant features observed were roof cladding degradation, detachment and disaggregation of interior coatings, general cracking, disaggregation of hand painted stucco, humidity spread in walls and ceilings, rottenness of timber elements and a number of *xylophagous* attack.

**Figure 2, 3, 4** – Broken and out of joint tiles; detachment and disaggregation of interior coating; rottenness of timber elements

The intervention plan leaned over treatment and reconstruction of the degraded elements, and reformulating of the entire water-proof roof system, particularly in exposed spots such as eaves, gutters and alongside periphery walls.
