Learning from a case study: the great timber roof structures of the Cathedral of Vercelli

EXTENDED ABSTRACT

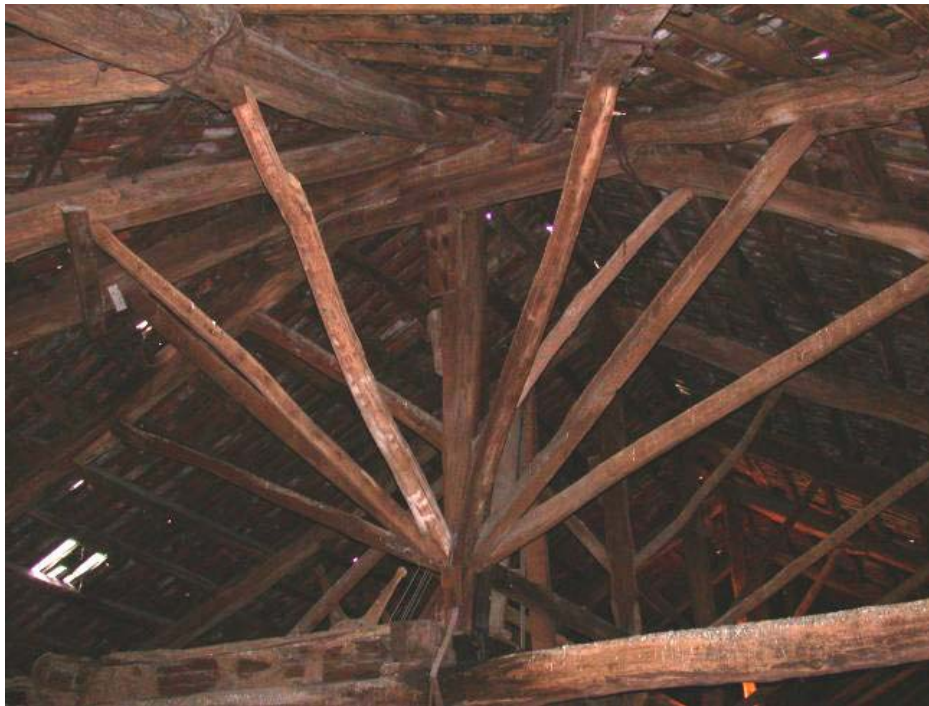
Figure 1 – Elements of the roof timber structure over the apse of the Cathedral of Vercelli Grading according to resistance
