Knowledge of the different roofing systems typologies in a public complex of XX century: geometric survey and material investigation

An articulated procedure has been applied for the structural and health assessment of the roofing systems of a public complex built at the beginning of XX century, eventually aimed to the safeguard of a relevant part of a valuable architectural heritage.

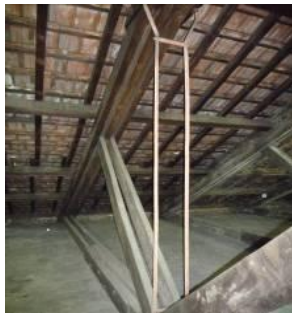
Figure 4 - Trusses of building 4

A comparison between the different building solutions adopted in the different parts of the construction and a recognition of the types of connections between the hanging devices and the timber trusses has been carried out (Figures 4 -6). Most of them are built in timber, in few cases reinforced concrete was used. Above the main rooms, trusses of bigger size and higher complexity are present. In many cases the timber trusses of the studied roofing systems spanning over large rooms are bearing brickwork vaulted structures hanging below. The large structures, partially hanged to the timber

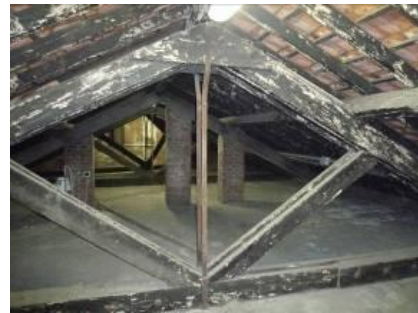
Figure 5 - Trusses of building 8

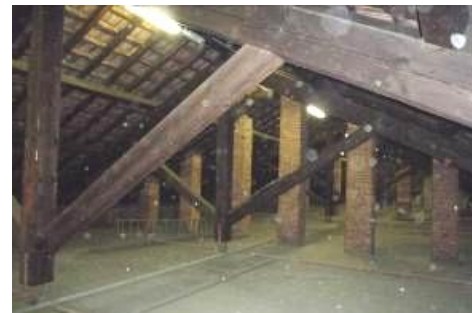
Figure 6 - Trusses of building 7

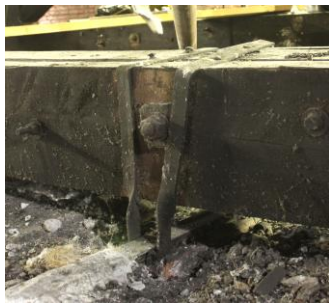
By local inspection two kinds of connections between the vault and the roofing system were recognized. The first type, like those adopted in the case of the hanging devices shown in Figure 7, consists of metal strips bolted to the beam web. The second one, shown in Figure 8, consists of metal strips wrapped below the upper beam flange.

Figure 7 - Connection between timber truss and I beam through strips bolted to the web.
