An experimental approach to the treatment and consolidation of degraded timber elements from a XIX century building

EXTENDED ABSTRACT

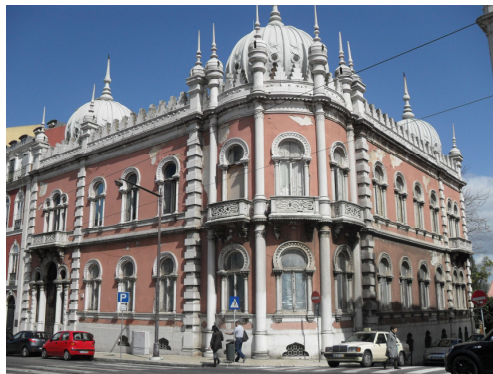
The building under study (figure 1) has been vacant since 2003 but remains in a reasonable conservation state. In terms of the timber elements condition some disperse and superficial degradation by wood-worm can be found as well as some fungal degradation in specific areas. This particular degradation results mainly from water leakage points in the roof and façades and also from the rupture of a pipe from the domestic water system.

Figure 1 – Palace Ribeiro da Cunha, Lisbon, Portugal

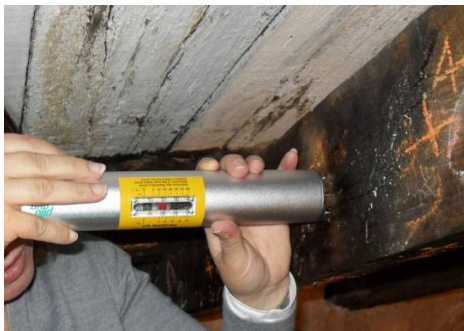
a. *Pilodyn* test in roof beam

Figure 2 – *In situ* testing of elements

The evaluation of the performance of the consolidant was made in situ, given the fact that it is neither possible nor desirable to move the elements to laboratory premises. The consolidation efficacy was checked using non-destructive tests performed with the Pilodyn® and Resistograph® apparatus (figure 2), before and after the application of the products F. The ability of these equipments for the estimation of timber properties was previously checked.

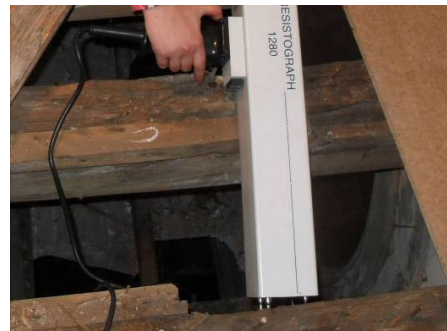
b. *Resistograph* in Pavement2 beam
