Assessment and intervention on the timber structure of a XVII century building in Lisbon; an example of seismic retrofitting.

Abstract The present work aims describing the interventions performed on the timber structures of Valadares Palace, a building reconstructed after the 1755 Lisbon earthquake and endowed with some of the constructive techniques applied to the Lisbon post-seismic constructions, namely a large number of timber structural elements at floors, roofs, interior walls and even within the exterior stone masonry walls. The Nucleus for the Conservation and Rehabilitation of Buildings and Built Heritage (NCREP) of the Faculty of Engineering of Porto University (FEUP) was responsible for the structural rehabilitation project, which aimed simultaneously the improvement of the global behaviour of the building through localized interventions using traditional materials and techniques and the preservation of the majority of the building's structural elements.

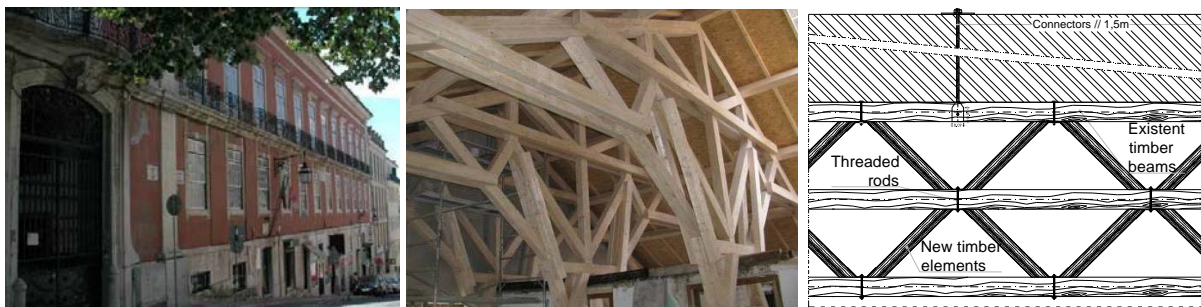
Figure 1 – Exterior photo of Valadares Palace and details of the structural intervention.

The implementation of the intervention measures, sustained by the conclusions of the structural assessment (phase 0), was divided in two phases. The phase 1 aimed preparing the building to receive a temporary exhibition. It's important to mention that, due to a tightened schedule related to the opening day of the exhibition, the period of time to conclude the intervention was very limited. In this phase, the main structural interventions were: a) the strengthening of the connections between horizontal and vertical structural elements, i.e., between timber roofs and walls; b) the design of new glue-laminated timber roof trusses, according to fire and seismic-resistant code requirements; c) the rehabilitation and strengthening of the existing support structures of the ceilings.

The phase 2 of the intervention, which is still under development, aims the rehabilitation of the remaining building structures, namely the timber floors, the “frontal” walls and the stone masonry walls. Thus, the designed solutions aimed the promotion of a more global behaviour of the building, namely through the improvement of the connections between structural elements (floors, walls and roofs). The main structural solutions foreseen for this phase were: a) strengthening of the connections between timber floors and walls; b) strengthening of the in-plane and out-of-plane characteristics of the timber floors, ensuring an efficient diaphragm behaviour; c) reinforcement of the connections between the “frontal” walls and the stone masonry walls to ensure a global “box” behaviour, as required for seismic resistance; d) improvement of the local continuity of the “frontal” walls and of their global in-plane behaviour through the introduction of bracing elements.
